# Manhole Inspection Summary

Manhole # S49M\_\_010MH

Insp Date: **4/15/08 3:52 PM**

**Location** Address: **2639 hudson st**

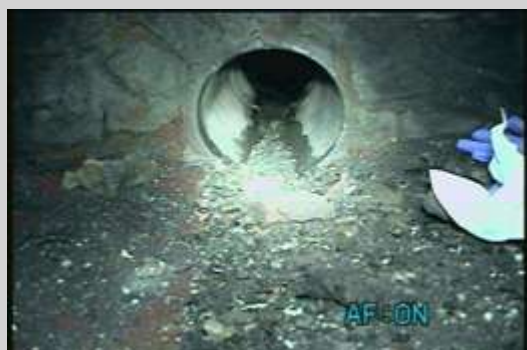
12 O'Clock Outflow

8 in. Circular Gravity Sewer  
Pipe Out @ 12 O'Clock

Pipe Material: **Clay** ☐ Pipe Lined

Infiltration: **None** Pipe Seal Cond: **Unknown**
